Greenforest Incorporated

REFERENCE: *THIRD Amended* Tree Health Report, Rose Hill West

SITE ADDRESS: Tax parcel Nos. 032505-9005, 9037, 9164, 9168, 9186, 9187

DATE: September 21, 2018

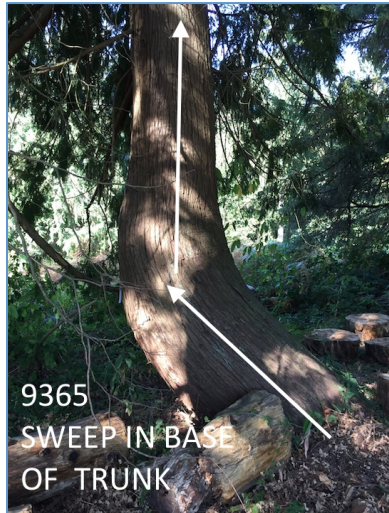
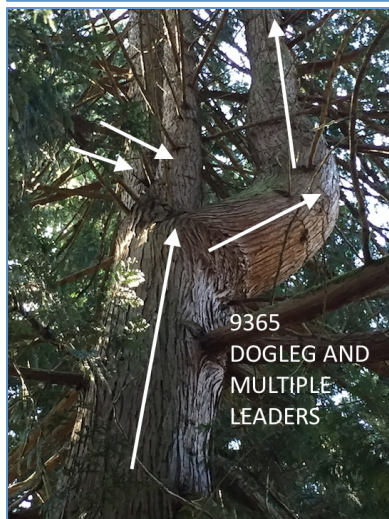
Tree 9365 has a significant sweep at the base of the trunk; multiple leaders in the upper canopy (left top and bottom).

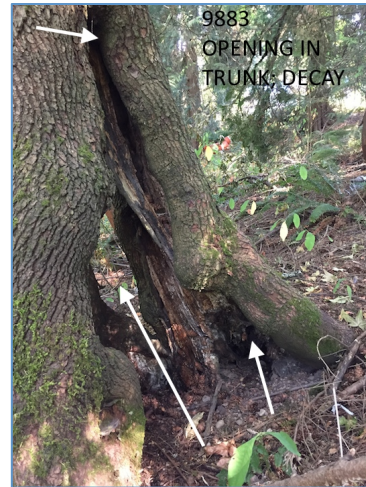
Tree 9883 has an open wound with advanced decay completely through the trunk (top right).

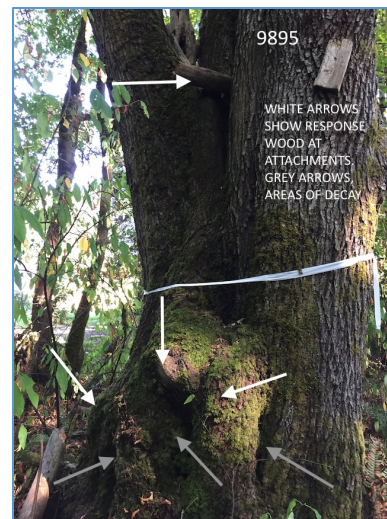
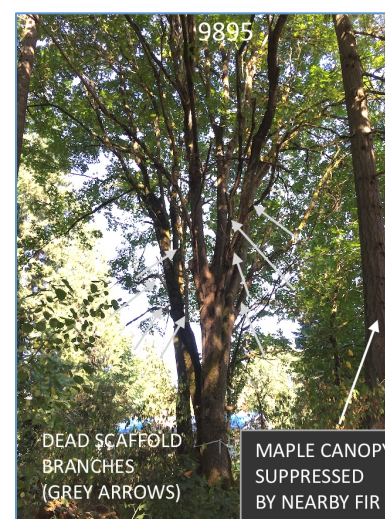
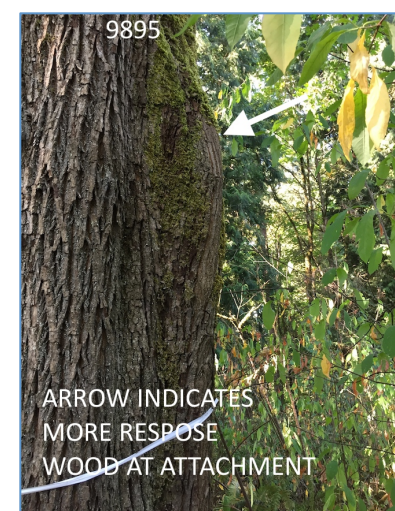
Tree 9895 is suppressed by an adjacent fir tree and its canopy is mostly on the abutting parcel. Several scaffold branches in the lower canopy are dead; response wood is visible and pronounced at all trunk attachments at the base of the trunk. This indicates uneven loading in the wood fibers, and a predisposition to failure (bottom three right images).
